1st International Conference on Structural Integrity, ICONS-2014

Failure Analysis of Refractory Anchors of a Power Boiler

C. Soupramanien and J. Swaminathan*

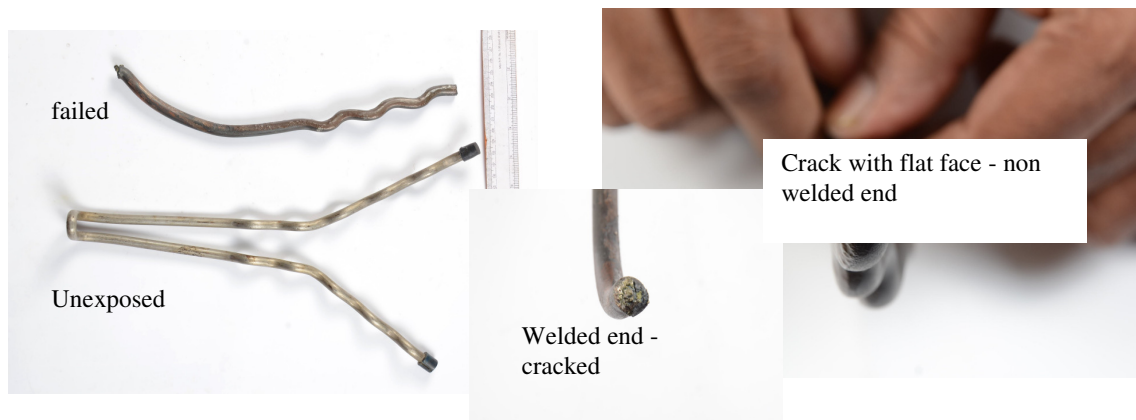
Photographs of the anchor rods under investigation were shown Fig.1. Unexposed anchor (7.85mm dia.) and the surface appeared with smooth finish. Failed anchor rod (9.85mm dia.) appeared with erosion marks left by the hot fluidised process media and discoloured due to oxidation but it was not severe as shown by presence of thin layer of scale. The non-welded end of the failed anchor rod showed a flat fractured face. Few circumferential cracks were seen in this side of anchor rod. The flat fracture face might have been from one such crack.

Fig.1 Photographs of the unexposed and service exposed anchors

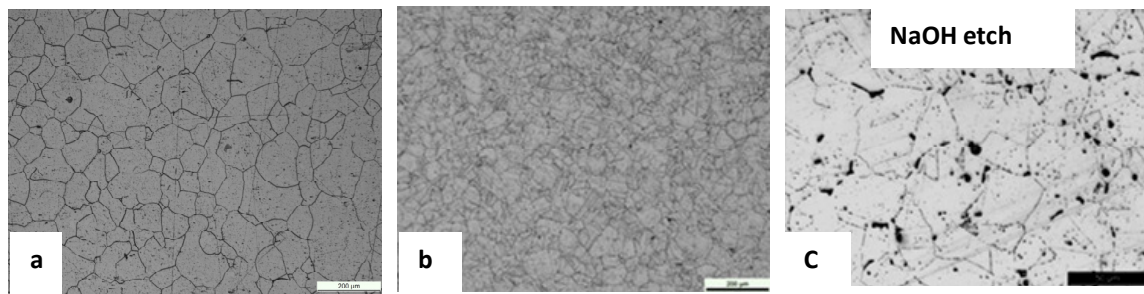
Optical micrographs of unexposed and failed anchors were shown in Fig. 2. Observed microstructure is typical of a austenitic stainless steel. Sigma phase (s) was observed only for the failed anchor (Fig.2c) at grain boundaries and at grain interiors. The failed welded end clearly revealed (Fig.3a) the weld solidified zone and a recrystallised fine grain zone adjacent to it. Higher magnification view of the welded zone showed (Fig.3b) presence of delta (d) ferrite. Grain boundary cracks were noticed (Fig.3c) in coarse grained HAZ adjacent to the weld and these cracks were actually formed along the continuous network of grain boundary carbide precipitates

Fig.2. Optical micrographs of anchors (a) unexposed (b) and (c) failed. Sigma phase seen as dark precipitates after electrolytic etching with NaOH

In the present failure, S- phase presence was identified (Figs.2c&5b). Being a hard intermetallic phase, presence of S-phase can be indicated by lower ductility, lower impact strength and increased hardness compared to that in unexposed condition. S-phase presence reflected on hardness (Table 2) and on tensile ductility (Table 3). Due to non-availability of enough material, impact tests could not be carried out. Fractographs (Figs. 4&5) further confirms it. If inadequate expansion joint exist, opening of refractory joints and entry of hot flue gases in between the refractory joints may occur to heat up the refractory and anchor rods well above the permitted range. This effect may also extend the size of the S- phase prone zone. Plant reported inadequate expansion joint and damage to backup insulation layer. Appearance of buckled outer shell with burn marks at the failed refractory location further confirms this fact. Oxidised nature of the cracked/fractured surface, erosion of the surface at one side of the rod confirms that embedded rods got exposed to hot flue gases. From these points, it is clear that the failure at the non-welded end of the anchor happened due to S- phase embrittlement caused by thermal exposure in the S- phase formation range. Frequent thermal load disruptions due to shutdowns caused shock loading of the anchor and thus S-phase embrittlement induced cracking occurred leading to lesser support for the refractory which subsequently failed.

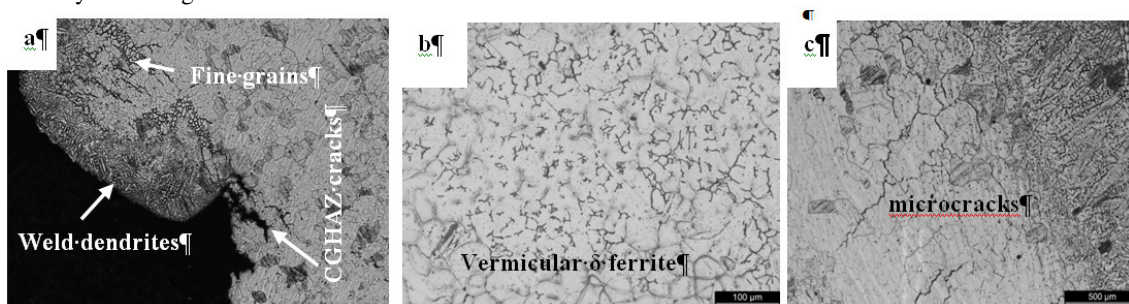
Optical micrographs of unexposed and failed anchors were shown in Fig. 2. Observed microstructure is typical of a austenitic stainless steel. Only failed anchor material showed (Fig. 2c) grain boundary carbides along with sigma phase at the grain boundaries and at the grain interior. The failed welded end clearly revealed (Fig.3a) the weld solidified zone and a recrystallised fine grain zone adjacent to it. Higher magnification view of the welded zone showed (Fig.3b) presence of delta (δ) ferrite. Grain boundary cracks were noticed (Fig.3c) in coarse grained HAZ adjacent to the weld and these cracks were actually formed along the continuous network of grain boundary carbide precipitates.

Fig.3 Optical micrographs of longitudinal section of failed anchor welded end side (a) weld solidified area with fine and coarse grain areas (b) delta ferrite in the fine grain area (c) microcracks along the coarse grain boundaries

The failure of anchor rod at the SS–MS welded end side occurred in the weld zone was confirmed by microstructural observations (Fig.3). Presence of S- phase, d-ferrite, continuous network of carbide at the grain boundary, microcracks in CGHAZ all points to a poor quality of weld. Non-availability of a service exposed but un-failed SS-mild steel weld for investigation and information on the weld consumables, welding method made decision on the exact cause of primary weld failure of the anchor rod a little bit difficult. In the refractory industry it is commonly observed that there is no written weld procedure which is qualified by tests like composition analysis, mechanical properties testing and corrosion testing. As per specifications [4], for welding AISI309 SS to mild steel, low carbon 309S electrode is recommended to balance weld composition to have δ ferrite content of 2.5-10%. Less than 2% ferrite will result in micro cracking of weld and excess of 10% δ ferrite, formation of S-phase and consequent embrittlement problem have to be faced up on. Since no information on the consumable is available, final ferrite content in the weld could not be predicted. Vermicular d-ferrite can form when a Cr- rich stainless steel like AISI309 solidified as primary d-ferrite. Subsequent cooling in the d-ferrite - austenite region, Cr-rich core region of the dendrite result in vermicular ferrite while Cr-low outer region transforms to austenite. Appearance of vermicular ferrite in weld (Fig.3b) is thus normal. Considering the shorter life of 3 years, carbon migration related degradation can be ruled out.

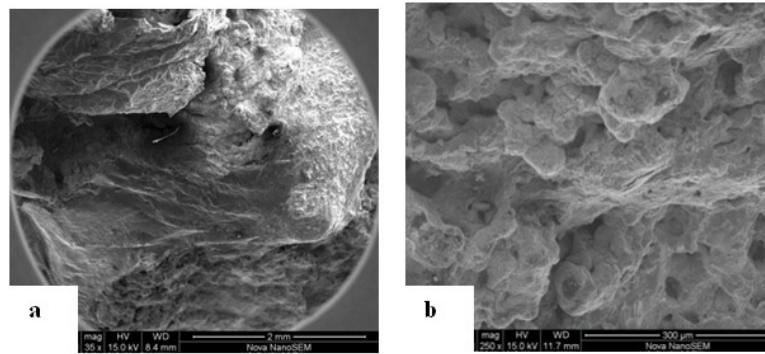
Scanning electron microscope was used to analyse the microstructure of failed and unexposed anchor materials. Much of the fracture surface got oxidised due to exposure to operating environment. A proprietary cleaning solution was used to remove the oxide layers. Fractured surface from the welded sided of the failed anchor showed several different features (Fig.4a). Though the oxide layers did not get removed fully, observed features (Fig.4b) fairly indicates that the fracture is mostly of intergranular type. Few cracks were also visible. Fractographic examination of tensile tested samples showed a brittle intergranular fracture for sample from failed anchor (Fig.5a). Unexposed anchor samples showed (Fig.5b) intergranular but with ductile features of void coalescence on the grain facets. EDX spectra analysis from a spot on fracture surface for tensile sample from failed anchor confirmed presence of sigma (σ) phase.

Fig.4 Electron micrographs of the failed anchor - welded side end

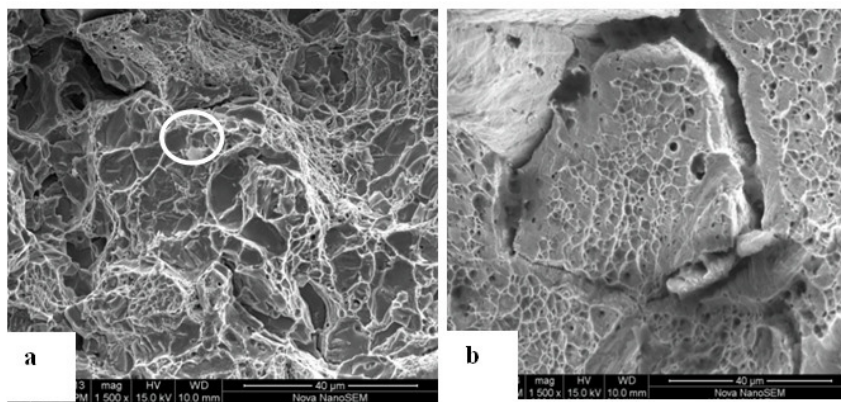
Element	Wt %
CK	00.63
SiK	00.31
CrK	30.16
FeK	59.10
NiK	05.83

Fig.5. Fractographs of tensile tested samples (a) failed (b) unexposed. EDX analysis of encircled spot given by the side.
